Canterbury Historic District Commission

Application for Certificate of Approval

Property Address 288 SHAKER RD - HORSE BARN Map# 228 Lot# 2

REPLACE ROOF IN KIND (SEE ATTACHED FOR DETAIL)
BECAUSE OF LIMITED IMPACT, WE REQUEST A WAIVER OF PUBLIC
HEARING, PLEASE.

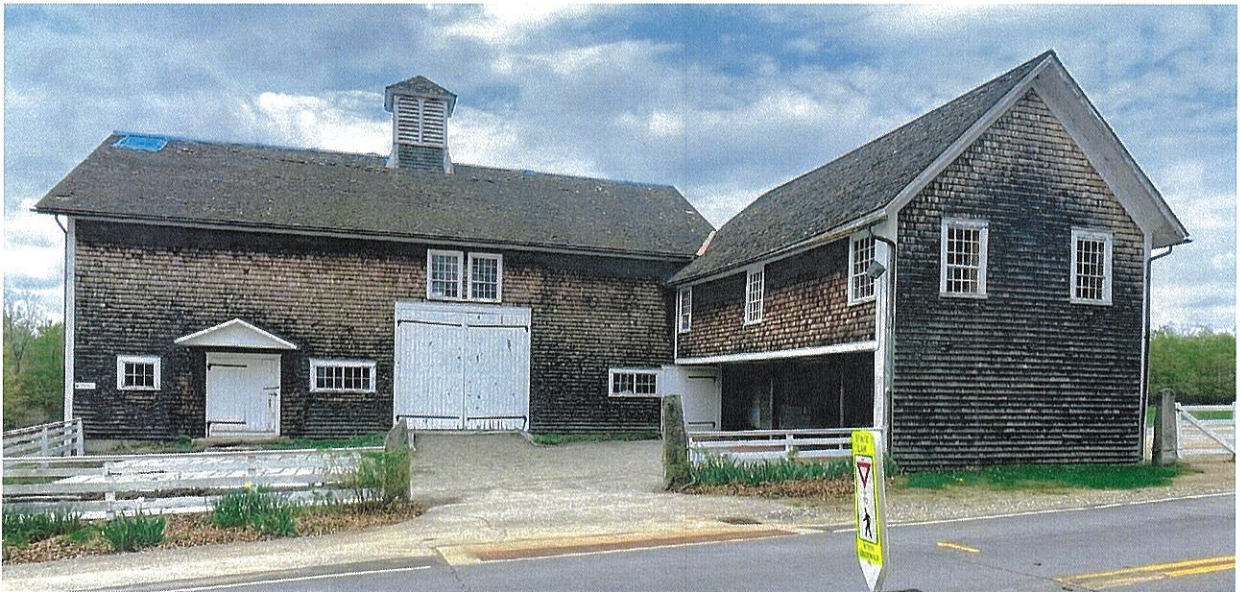
In 2021, Canterbury Shaker Village hired DBVW to conduct conditions assessments of several buildings at Canterbury Shaker Village, including the Horse Barn. That assessment noted that “The Horse Barn has a wood shingled, gable roof that is in poor condition. There is a small entry canopy on the east elevation with a wood shingled roof in similar condition. A small cupola with a wood shingled, hipped roof is present and in poor condition.” “There are copper gutters and downspouts in fair to poor condition. Some of the downspouts are damaged near grade. The southwest downspout is detached from its boot. All downspouts discharge to a below grade drainage system.” Other features of the Horse Barn were also assessed and determined to be lower priorities for work.

View of the Horse Barn from the east, showing current condition. Note blue tarp on the south end near the peak.

In alignment with the DBVW assessment, we propose to replace the wood shingled roof with a new wood roof, and replace copper flashing, and damaged copper downspouts, where/as necessary. Canterbury Shaker Village intended to replace the Horse Barn’s actively leaning in 2022-2023. However, because the Dwelling House roof was actively leaking, focus was turned to replacing the Dwelling House roof. So, the Horse Barn roof replacement was put on hold. Not surprisingly, its condition has gotten worse. The west slope of the roof is covered by its third generation of tarps, and yet it is leaking severely. Water in the building is managed to the extent possible by using buckets and kiddie pools to catch the water to minimize damage to the building and museum collection. But damage is being done. This project is now Canterbury Shaker Village’s highest priority for funding and completion.

Utilizing the same scope established for the Dwelling House’s cedar roof, we propose to remove the existing wood shingles, repair the roof deck as needed, install strapping (over moisture barrier and with screening at the eaves) to allow the roof to breathe, and then install the new cedar shingles and ridge boards. Copper flashing, gutters, and downspouts will be reused where possible, and replaced in kind where necessary. We expect to work with Davis Construction Company again, who did the work on the Dwelling House.

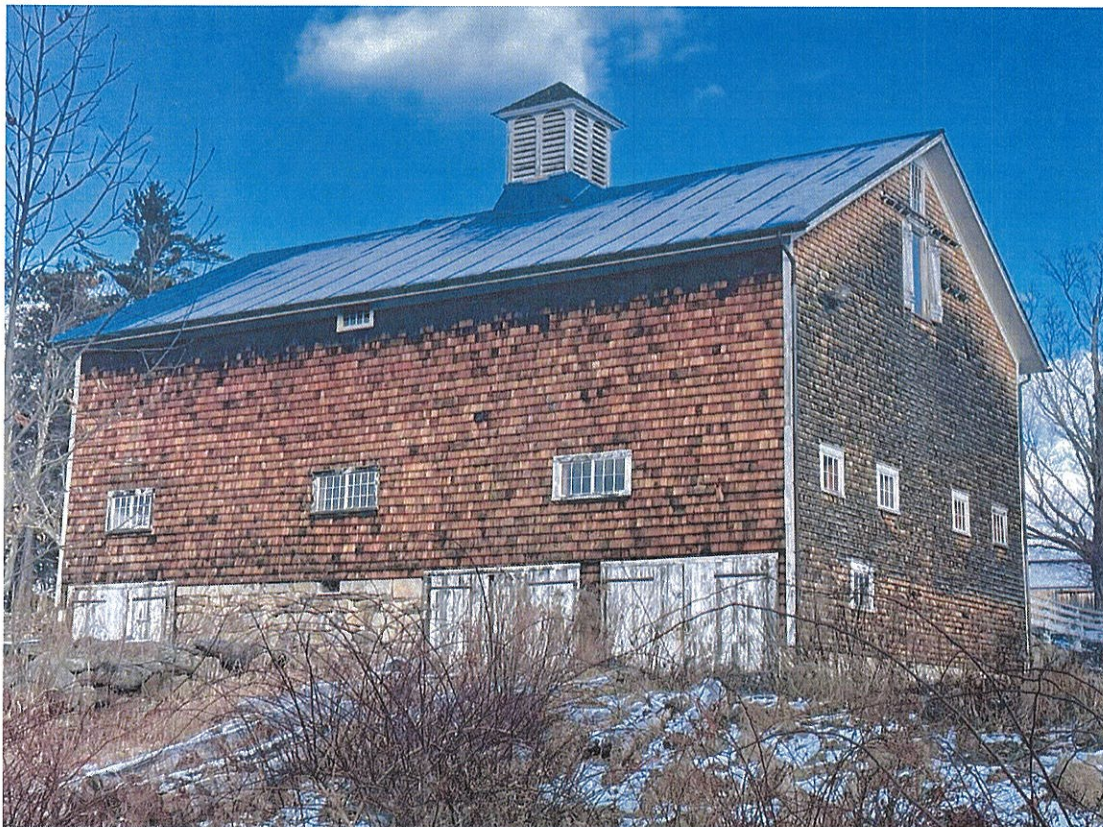
View of the Horse Barn facing northeast, showing third generation of blue tarp. The roof has failed and is actively leaking.

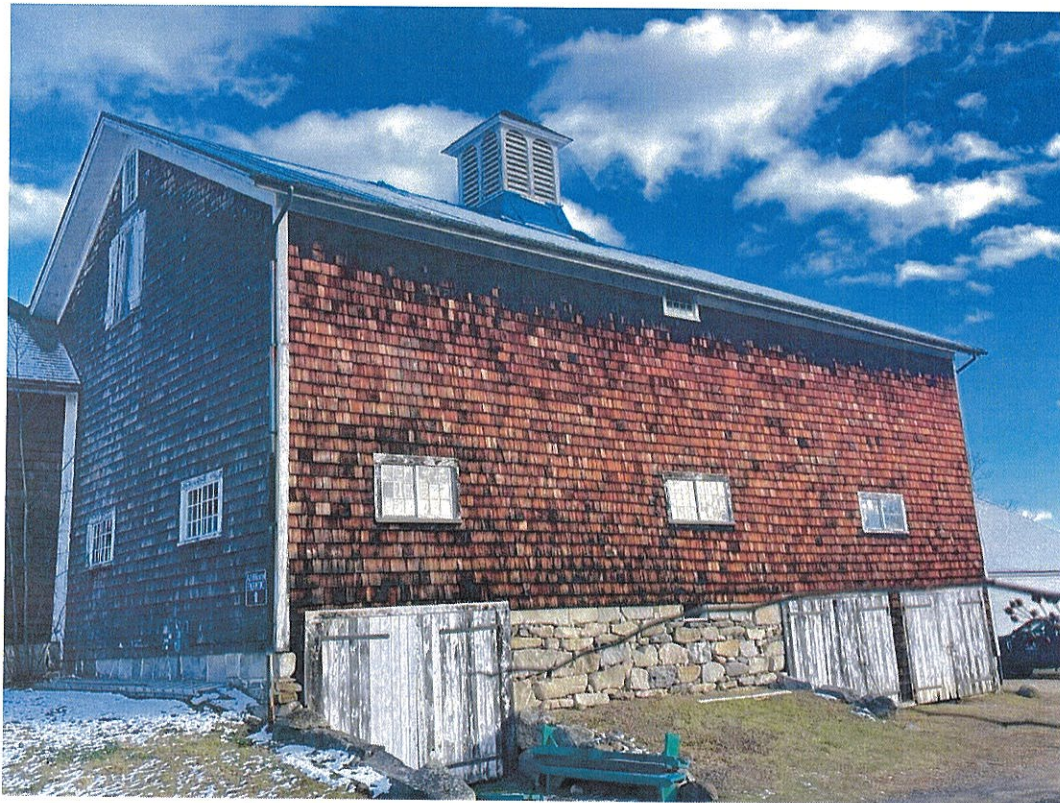
View of the Horse Barn with tarped roof, facing southeast.
