Appendix B Canterbury Historic District Commission Application for Certificate of Approval

Property Address 288 Shaker Rd - East House

Canterbury Shaker Village
East House
HDC Application

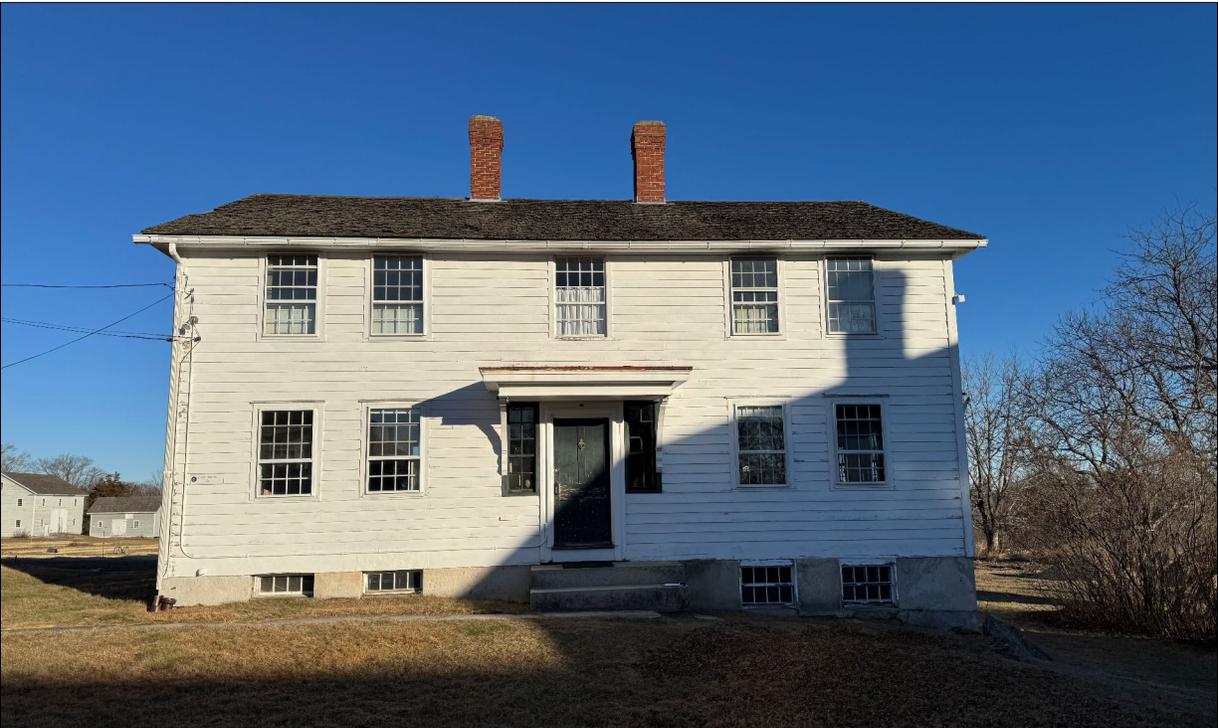
A 2.1: East façade of East House with wood clapboards (5½" exposure, scarf-jointed), 5" corner boards with corner bead, and a 10" apron along the front and gable ends (none along the east side).

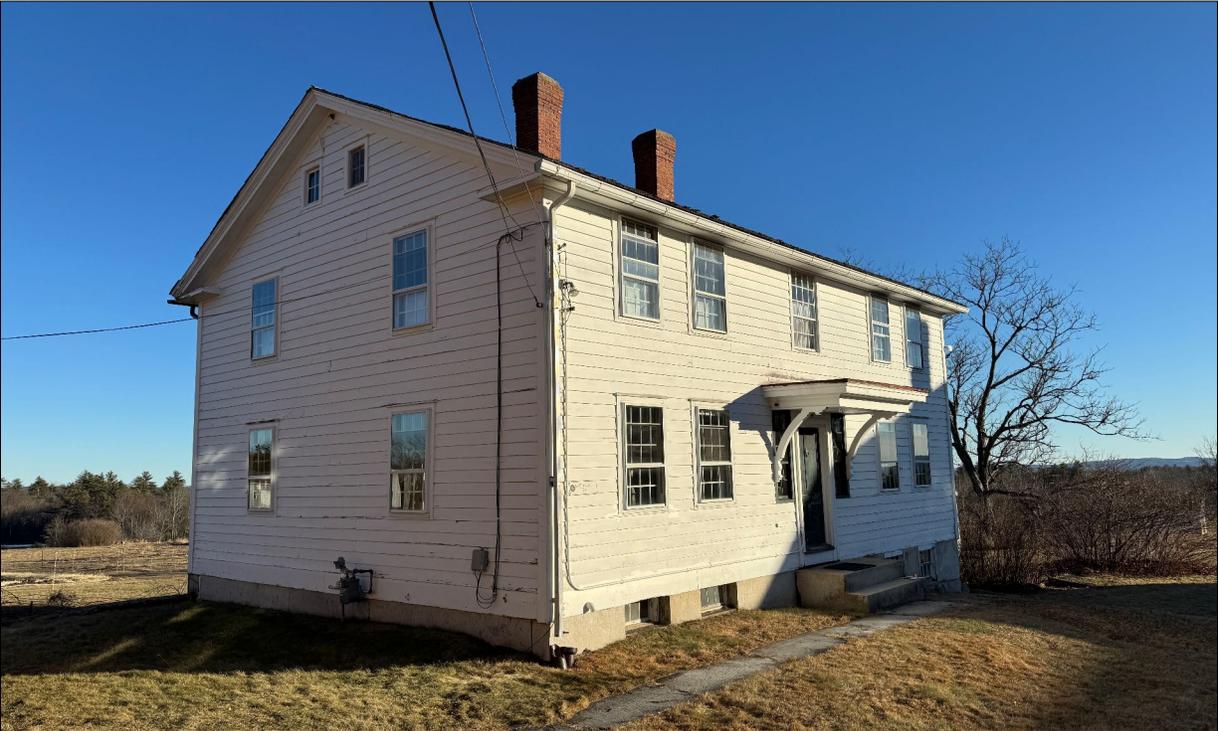
A 2.2: East façade and north gable end. Utility lines extend from the adjacent Sisters' House. Finished granite underpinning.

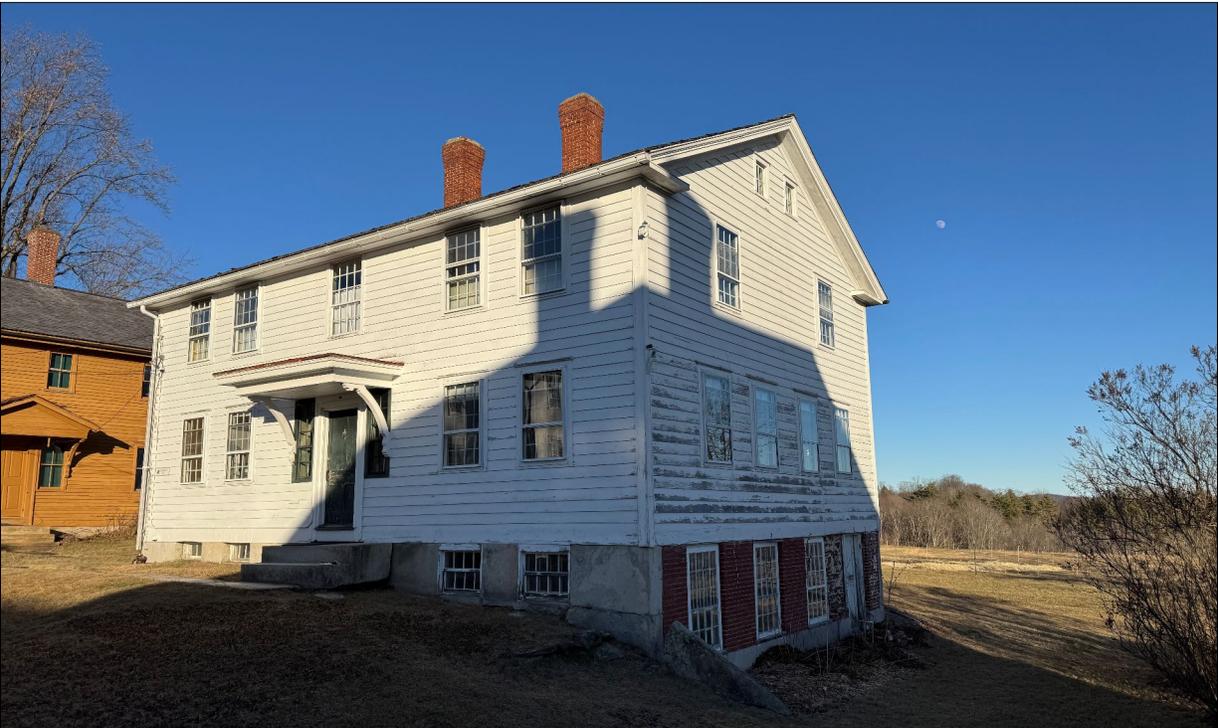
A 2.3: East façade and south gable. Grade drops at the SW corner to create a walk-in basement workshop enclosed by brick infill.

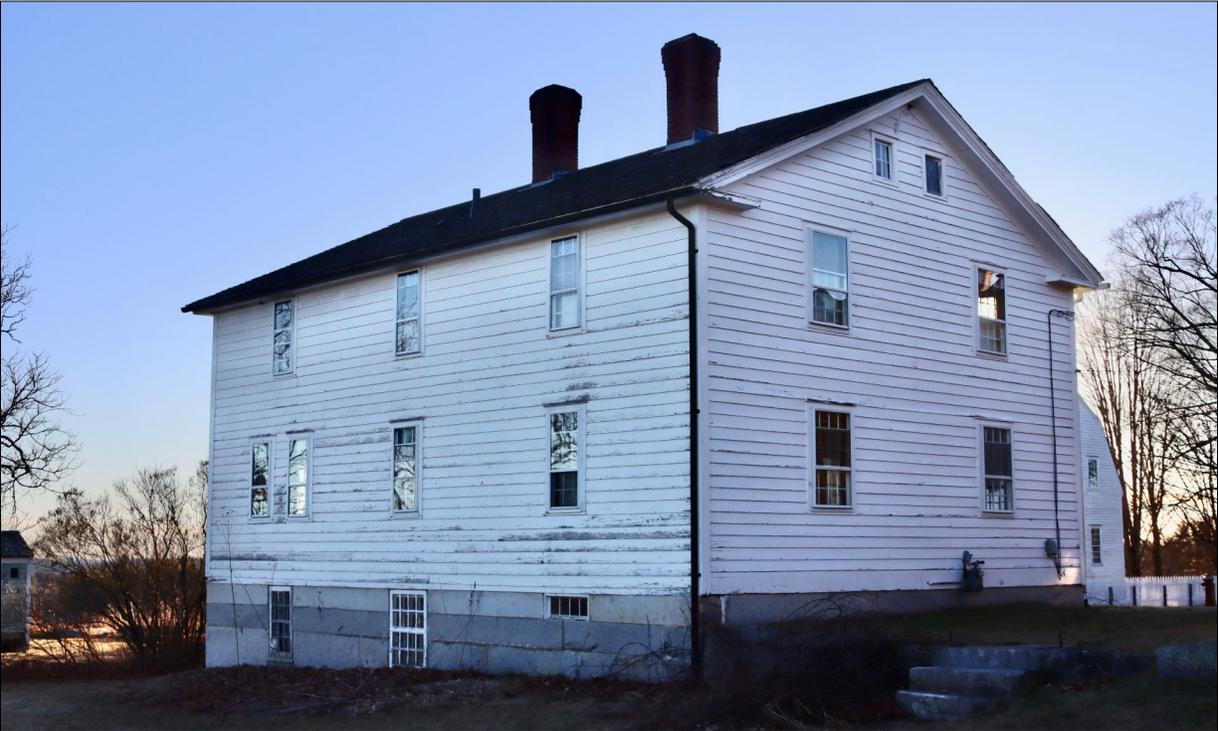
A 2.4: East elevation and north gable. Grade drops beyond a granite retaining wall which extends from the NE corner of the building. Dressed underpinning above rough granite foundation.

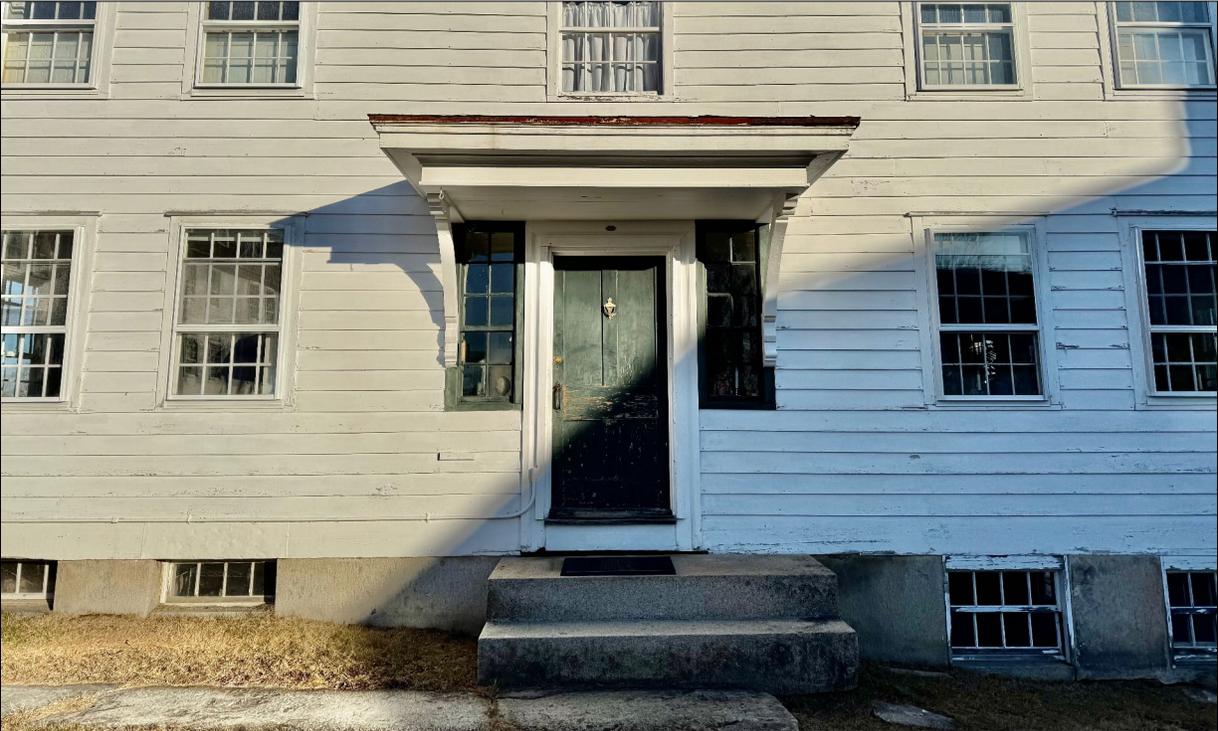
A 3.1: Entry assemblage: granite steps (oversize and not centered), four-panel main entry door with 6/4 sidelights and bracketed hood covered in soldered flat metal panels.

Existing 4ft 6in by 8ft 6in roof over western entry door appears to be in good shape except for paint and some rotted fascia boards, as well as the flat seamed painted tin roof.

1. Stage area, remove old metal and rotted fascia boards. Provide temporary waterproofing.
2. Replace rotted fascia boards, and any rotted sheathing found after flat seam metal roof is removed.
3. Install new flat seam painted metal roof to match original red. The new roof will have a positive drip to prevent the fascia from rotting again.

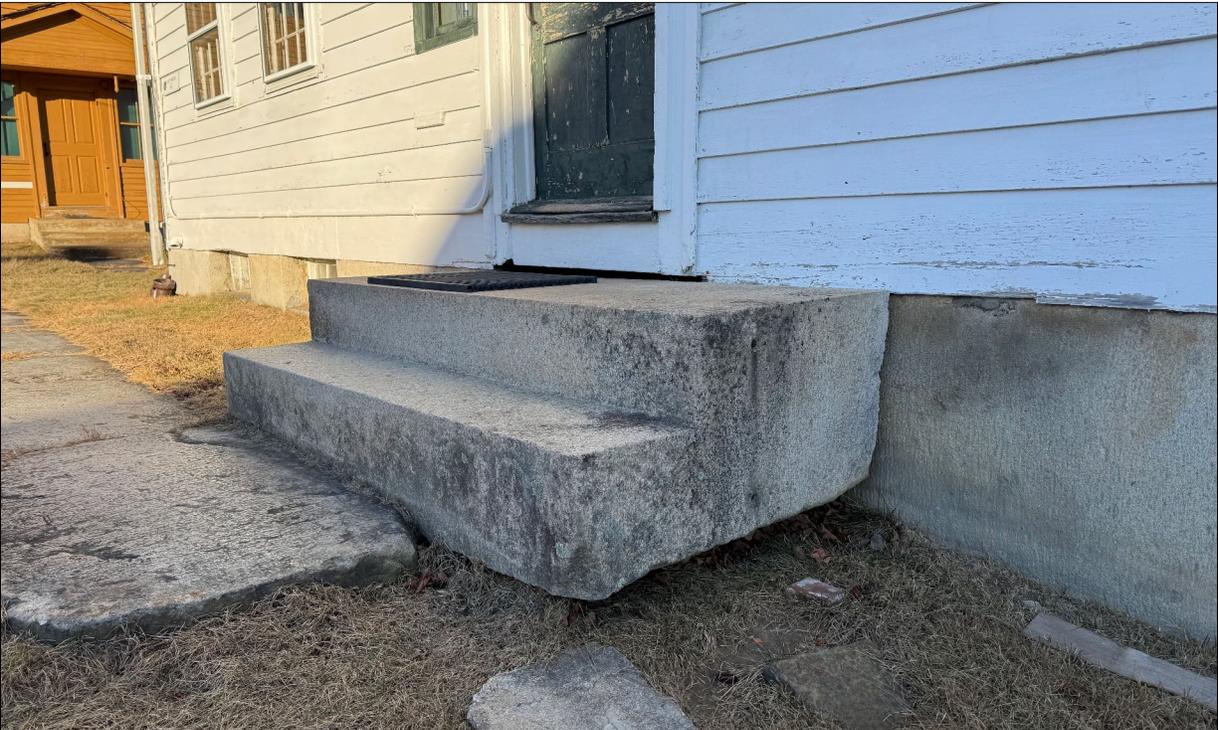
A 3.2: Steps to front door made from a single piece of granite. Earlier photos show a similar step (with scraper and handrail), but roughly matching the width of the 48" door.

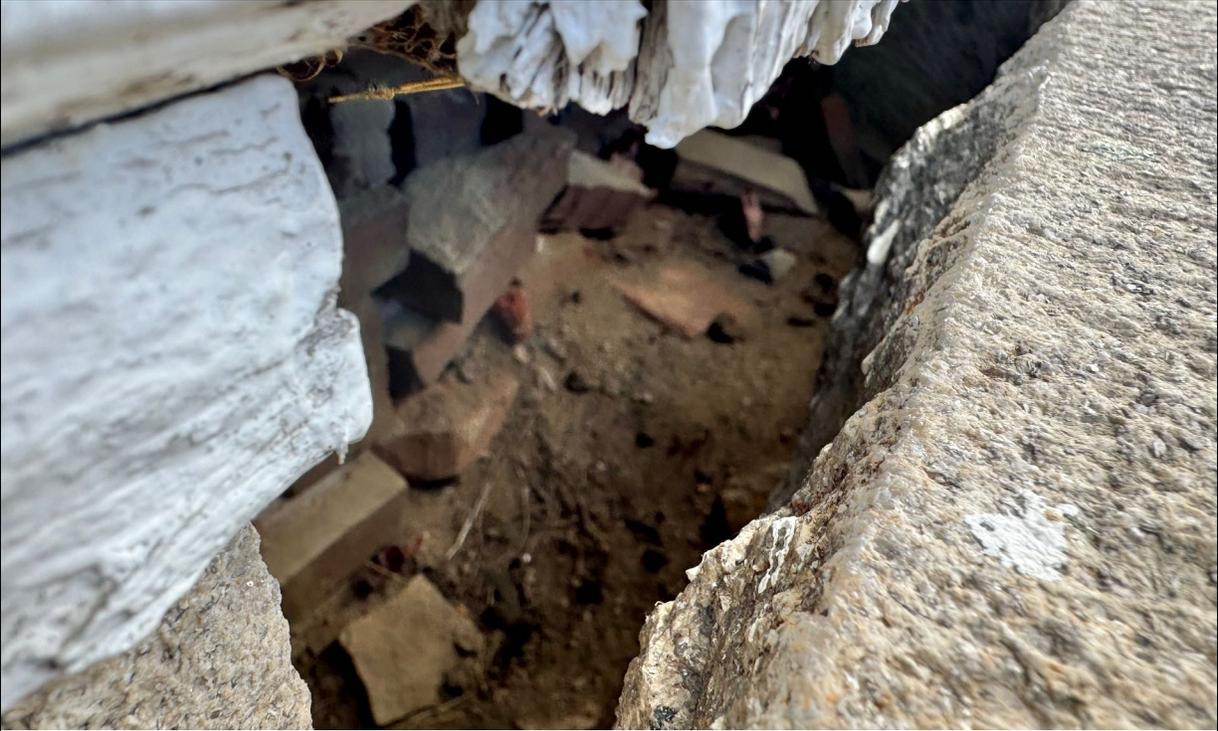
A 3.3: Wide gap between steps and collapsed inner brickwork; daylight visible from inside the basement.

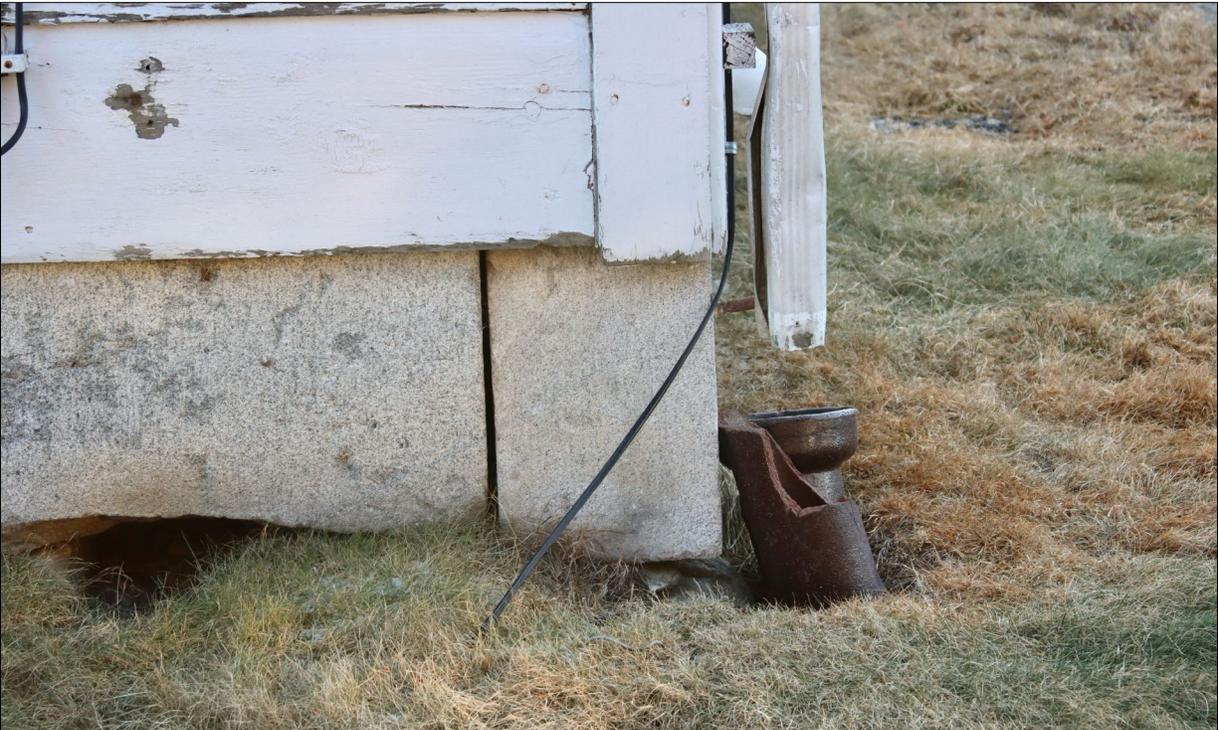
A 3.4: Broken connection between downspout and clay drainpipe; perhaps still functional; moisture is evident in the basement near this location.

Gutters and Downspouts – Gutter Done will replace the existing white K-style gutters and 3x4 downspouts, with straps and flashing as needed.

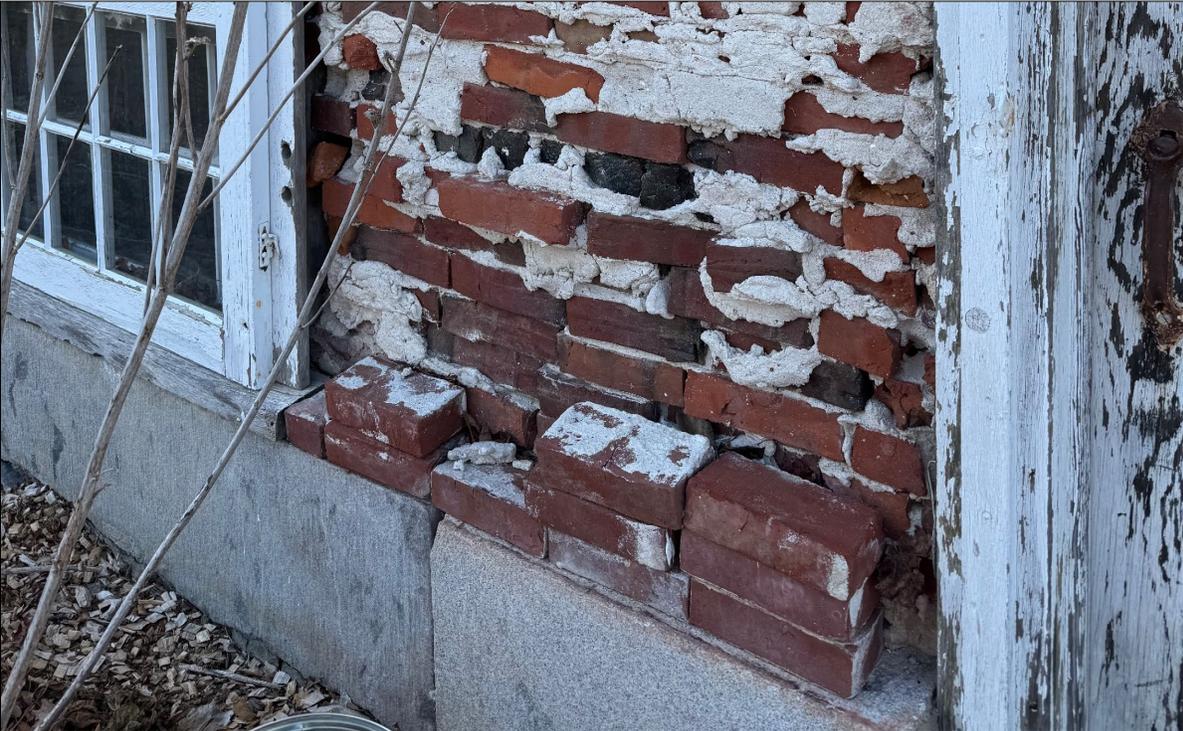
A 3.5: Brick veneer missing from one section along the south basement (next to exterior door); no evidence that face bricks were tied to those behind by anything but mortar. Note mis-matched granite, suggesting re-use.

Structural Repairs - The work will begin with repairs to the building's sill by Oliver Fifield and his team. They will lift the building slightly to remove deteriorated structural members and replace them. This work will not be visible from the exterior. Once that is done, ProPoint Restoration will rebuild the building's brick south foundation wall. Details are as follows:

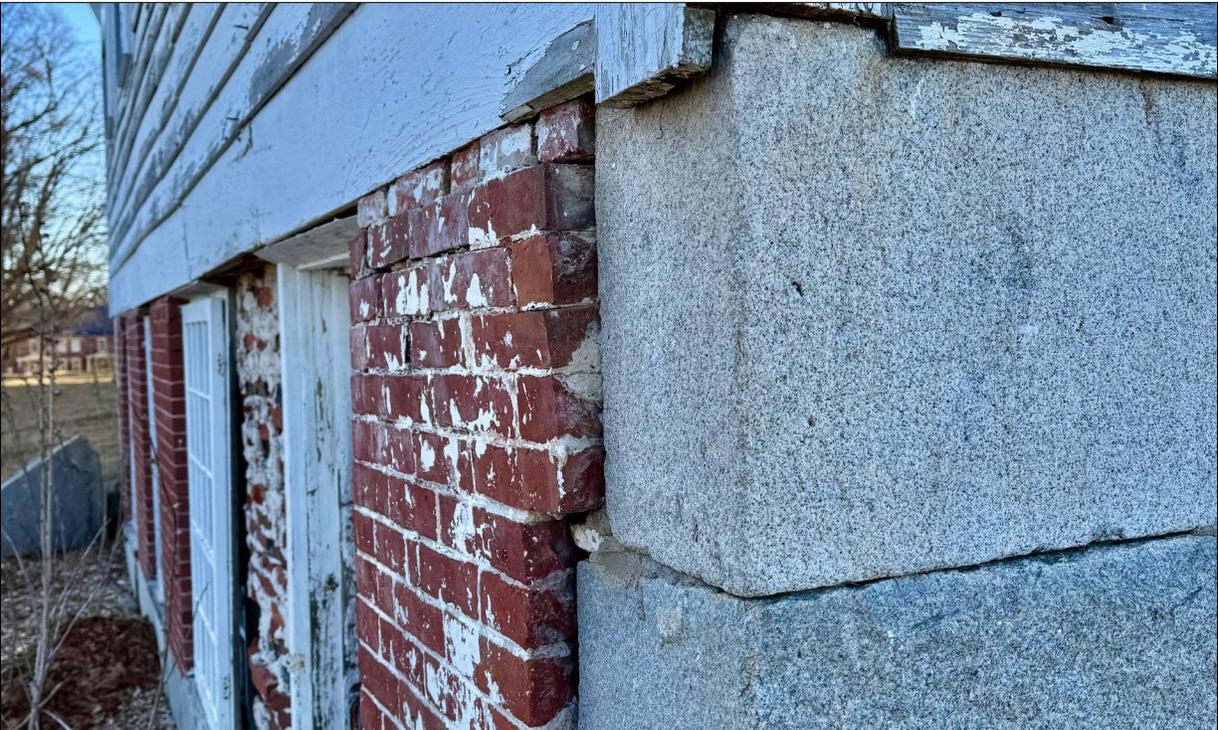
A 3.6: Broken connection with granite courses which form the SW corner; intact brick veneer lies several inches proud of the corner.

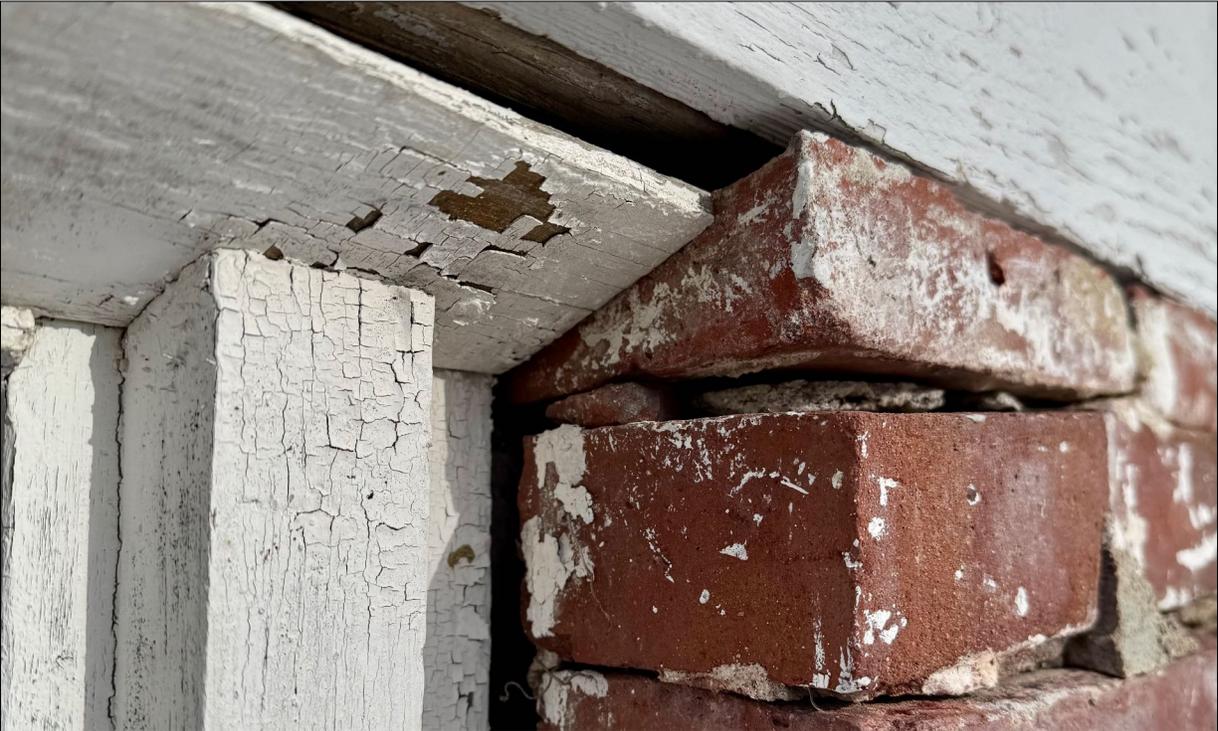
A 3.7: Windows sit loosely within openings in the south-facing brickwork.

4. Temporarily remove window units from south basement brick wall for masonry work, temporary weatherproofing installed.
5. Repair and/or replace rotted or otherwise unsuitable trim. Parts made to match existing profile and material. Exposed face of trim to be hand-planed to best match original manufacturing methods.

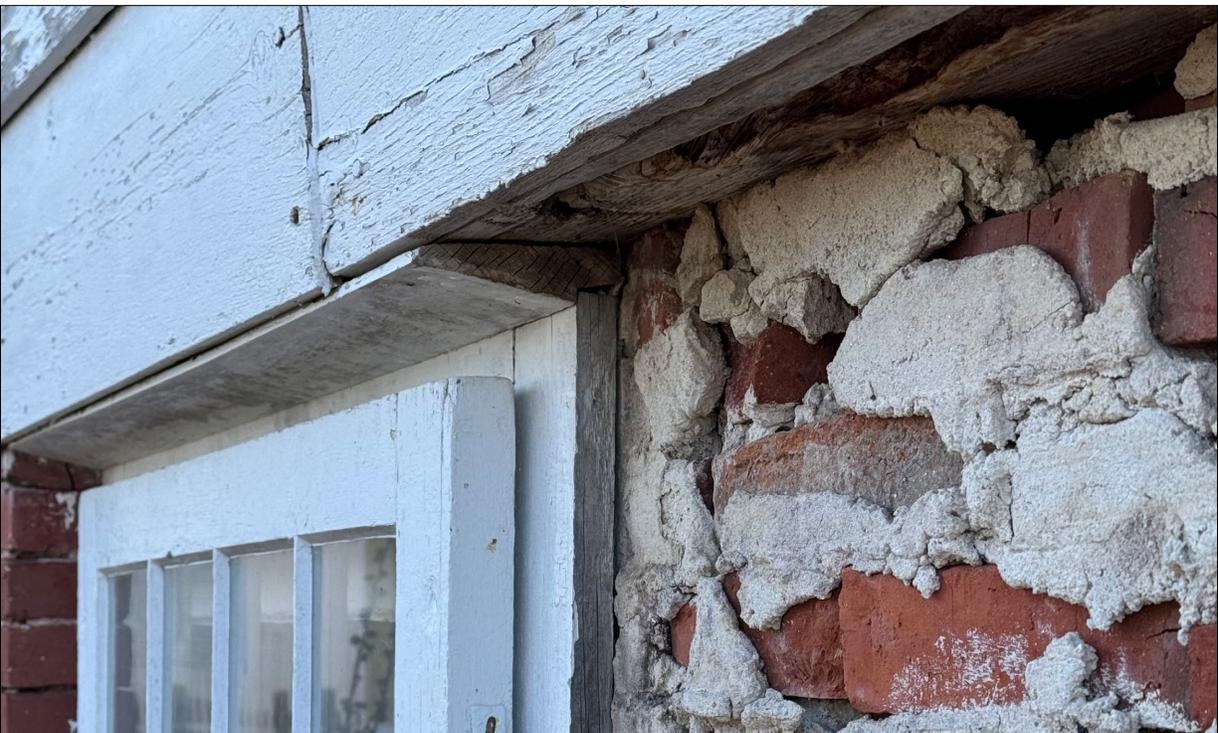
A 3.8: Exposed window frame (with attached storm window) within damaged brickwork; a section of the building's outer sill is rotted above (upper right).

5. Approximately 70 lf of sill will be replaced with hemlock 8x8 beams including the entire west side and sections of the north and south.
6. The interior second sill/carrying timber on the south wall will be replaced with an 8x8 hemlock timber. The two pre-existing post jacks removed and one permanent cellar post installed to half the span.

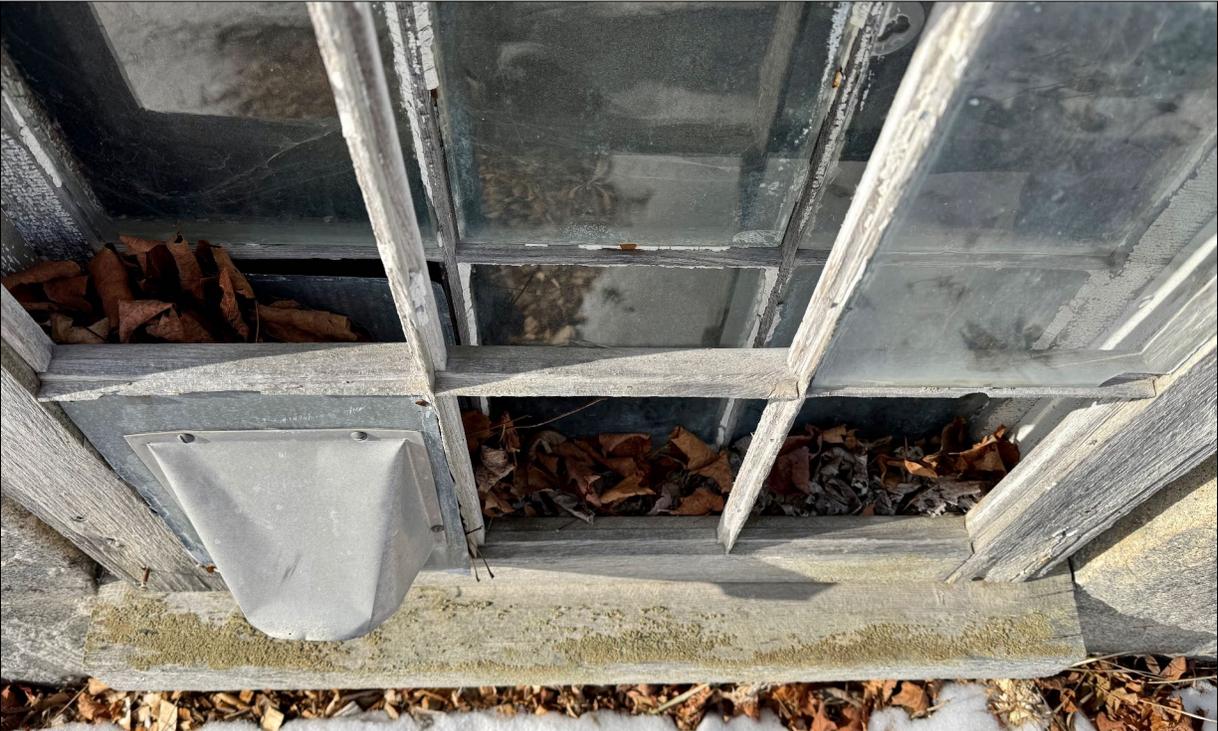
A 3.9: Laundry dryer vented through basement windows, which was covered on the interior when the laundry had been used as a darkroom. See photo B-0.10

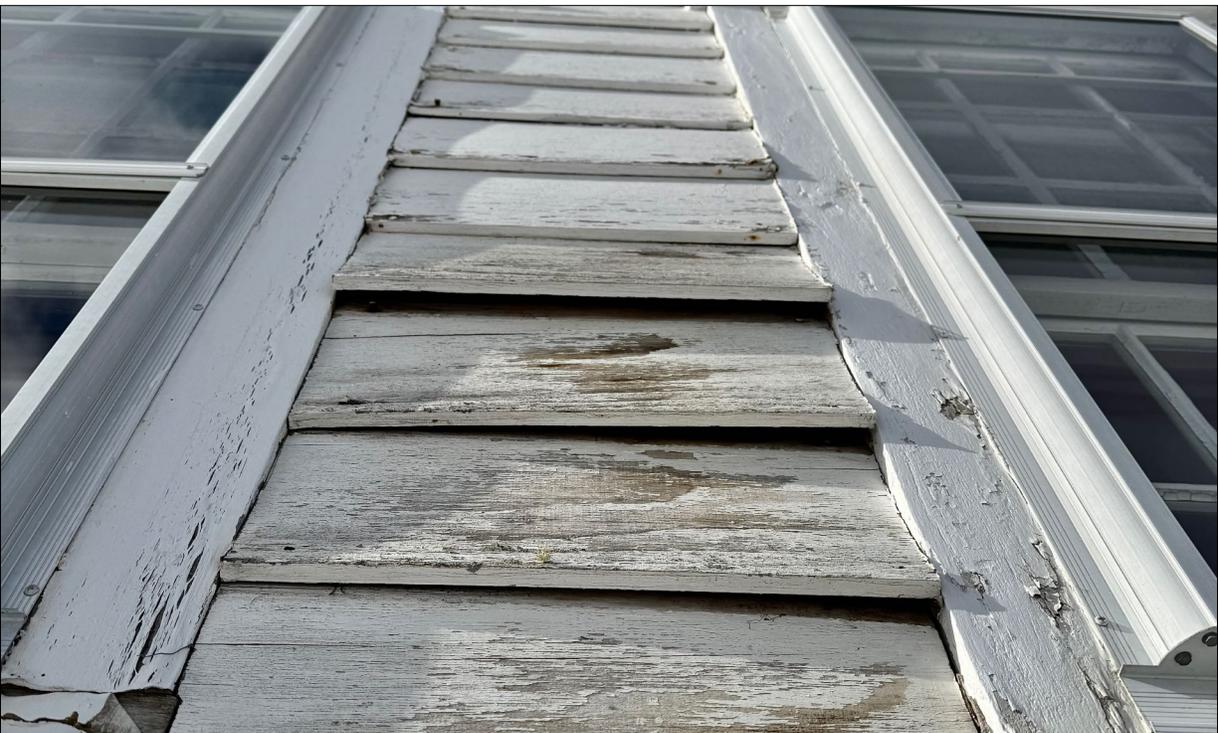
A 3.10: Loose siding and rotted window trim on east elevation require investigation to assess condition of sheathing and framing behind. Excess moisture may originate with dryer vent directly below.

2. Only rotted, split, or otherwise unsuitable clapboards to be replaced, all sound siding to be preserved and restored.
3. Remove storm windows, label and store onsite, assess damage. Reinstall storms after project is complete. Replacing or installing new storm windows is not included in this estimate. We recommend new storm windows be considered for basement level.

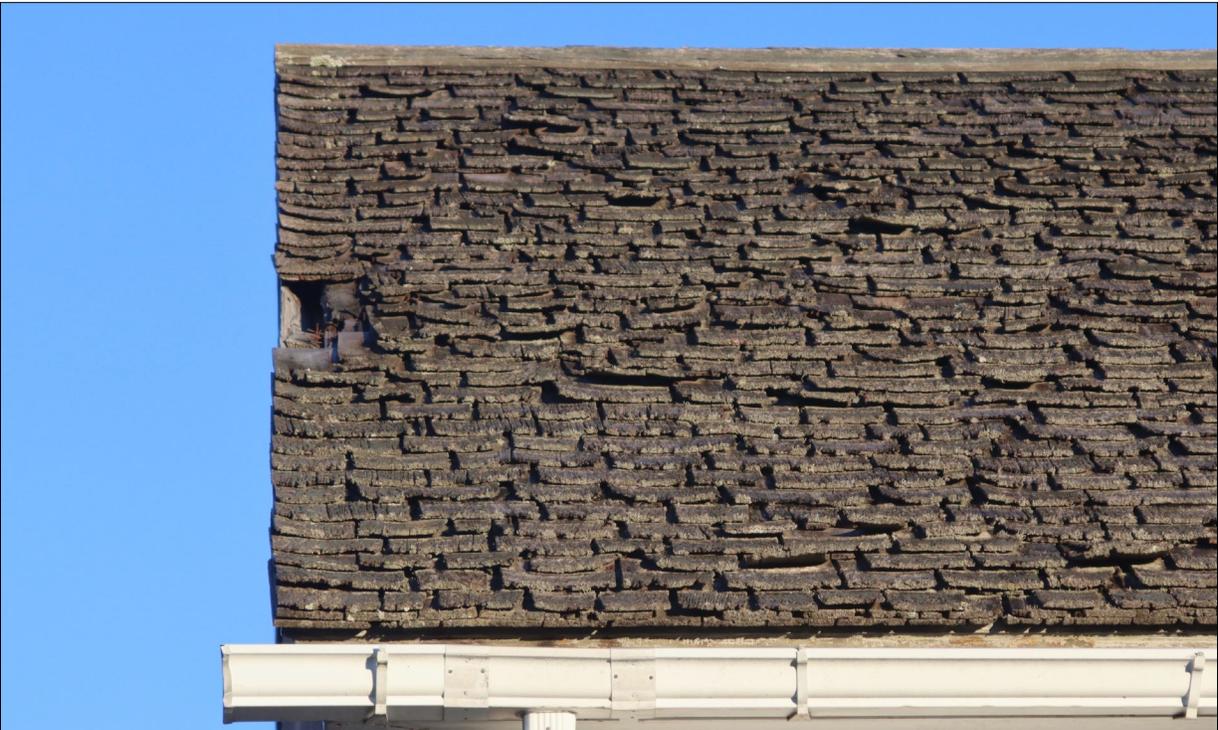
A 4.1: Wood shingles deteriorated, leaving gaps in the gable eave projection on the north end. Note: HABS photos (1969-70) show low profile asphalt shingles on this roof.

Roof - The building's wood shingled roof will be replaced, using new yellow cedar shingles matching those recently installed on the Dwelling House, Horse Barn, and Ministry Privy. Specifically, the contractor will:

4. Install 5/8 butt Alaskan yellow clear shakes with a 5" exposure to the weather. Ring shank stainless nails used. Each side of the roof is approximately 42'x17'6", 7.5 squares, or a total 15 square roof. 7 bundles 5/8 butt shakes/square this roof will require at minimum 105 bundles (should allow for some waste/cuts etc. **115 bundles** necessary).

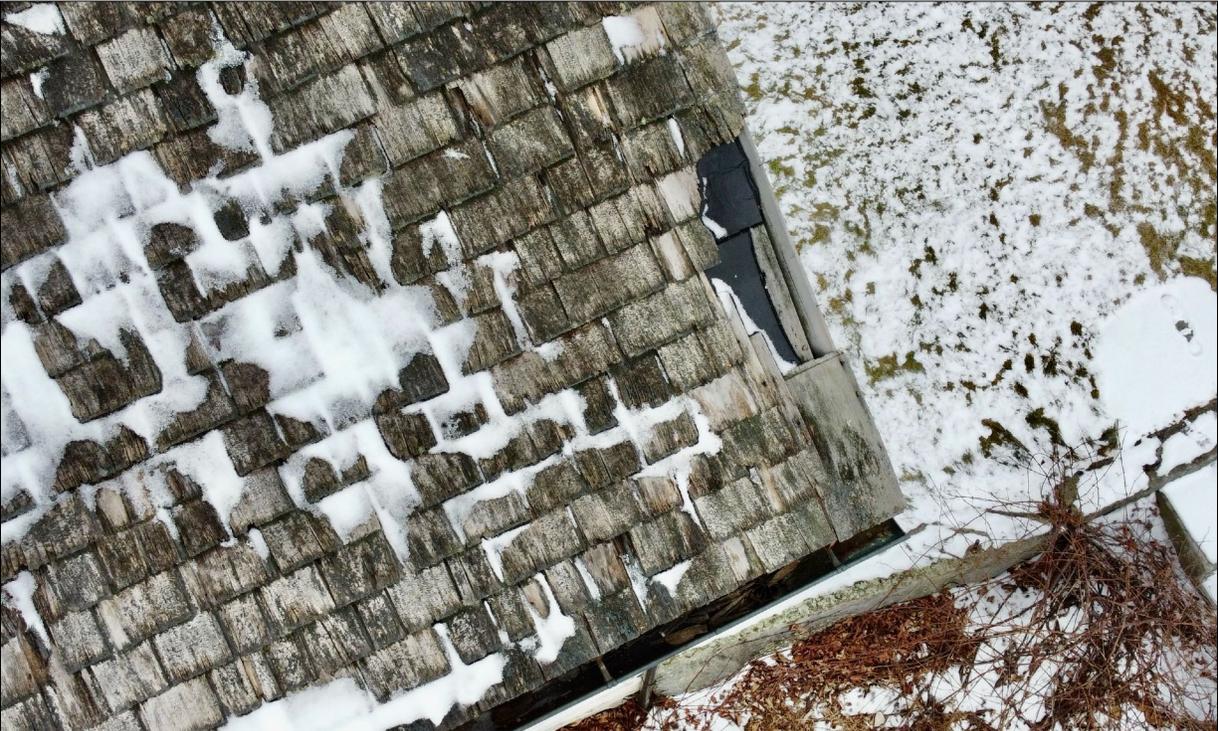
A 4.2: Wood shingles deteriorated, leaving gaps in the gable eave projection on the north end.

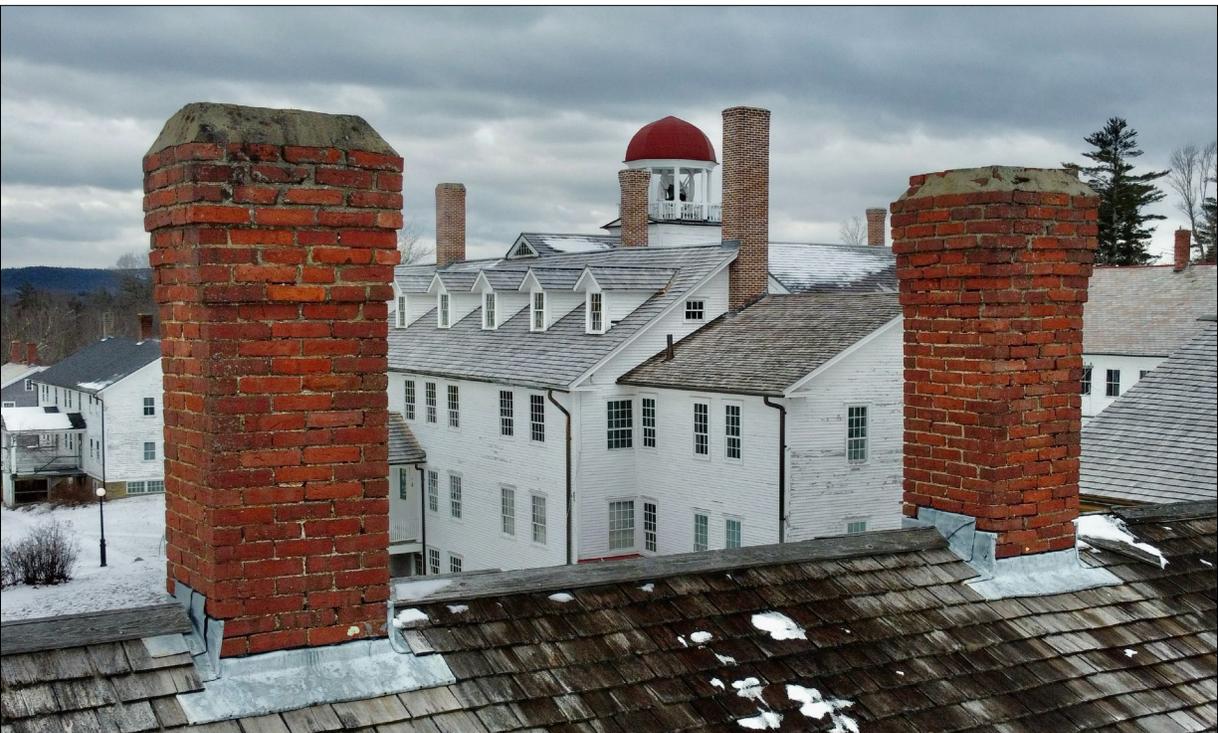
A 4.4: South chimney (left) appears slightly better than north but still requires repointing work.

Chimneys – ProPoint Restoration will re-point the building's brick chimneys. A mortar analysis has been done, showing that the existing mortar is soft Type L lime mortar. The same will be used for the current work.

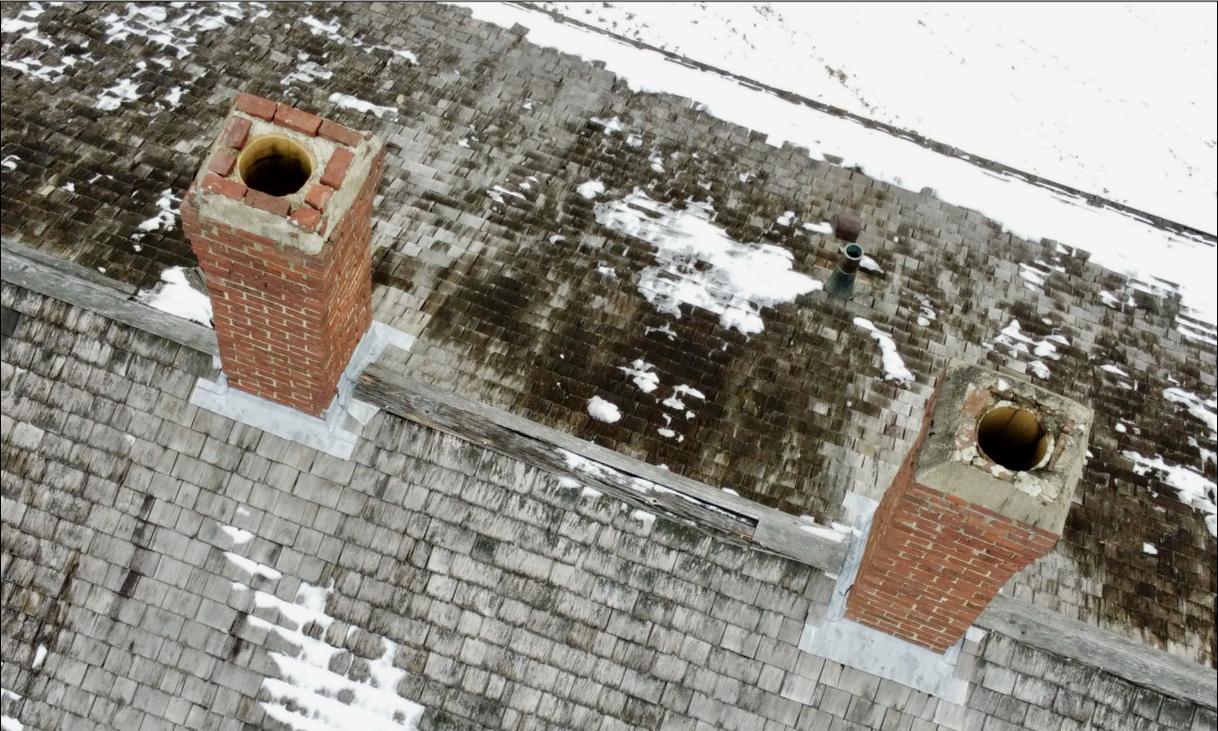
A 4.5: Chimney tops require new parging.

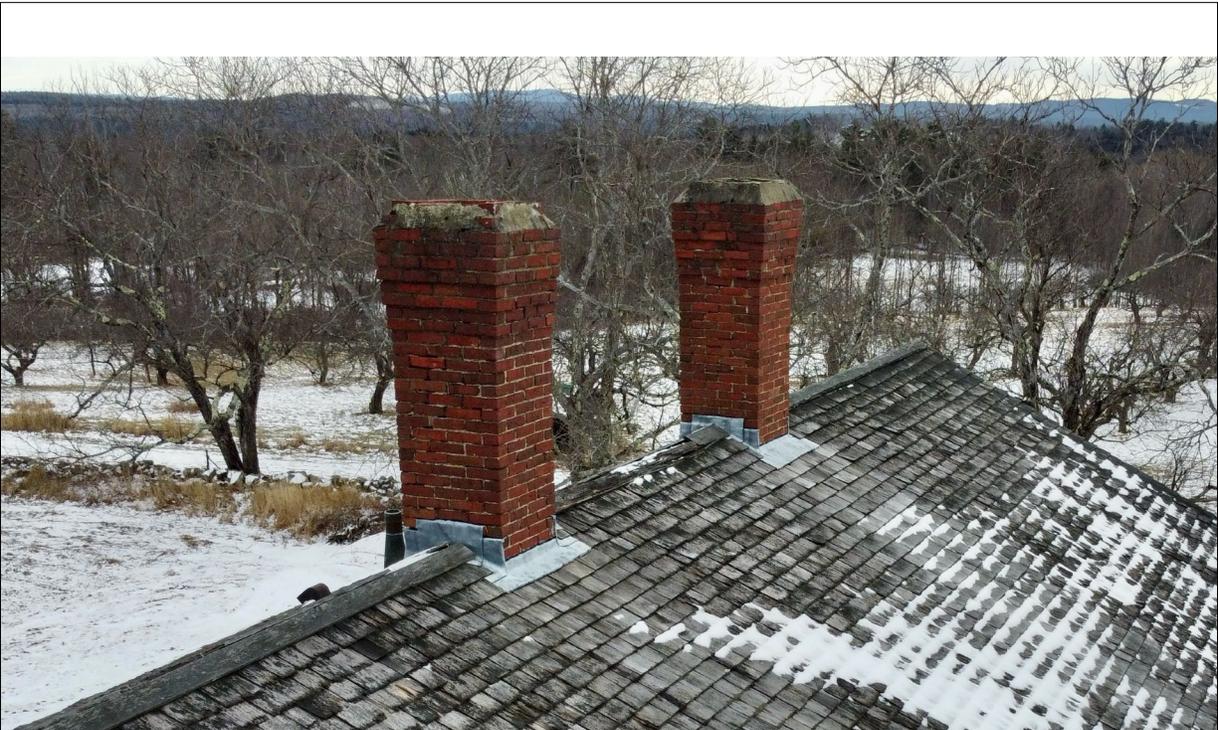
A 4.6: Another section of missing or deteriorated ridge cap between the two chimneys on the west side.

8. Clear red cedar ridge cap installed.
