Appendix B Canterbury Historic District Commission Application for Certificate of Approval

Canterbury Shaker Village Meeting House

REPAIR RECOMMENDATIONS

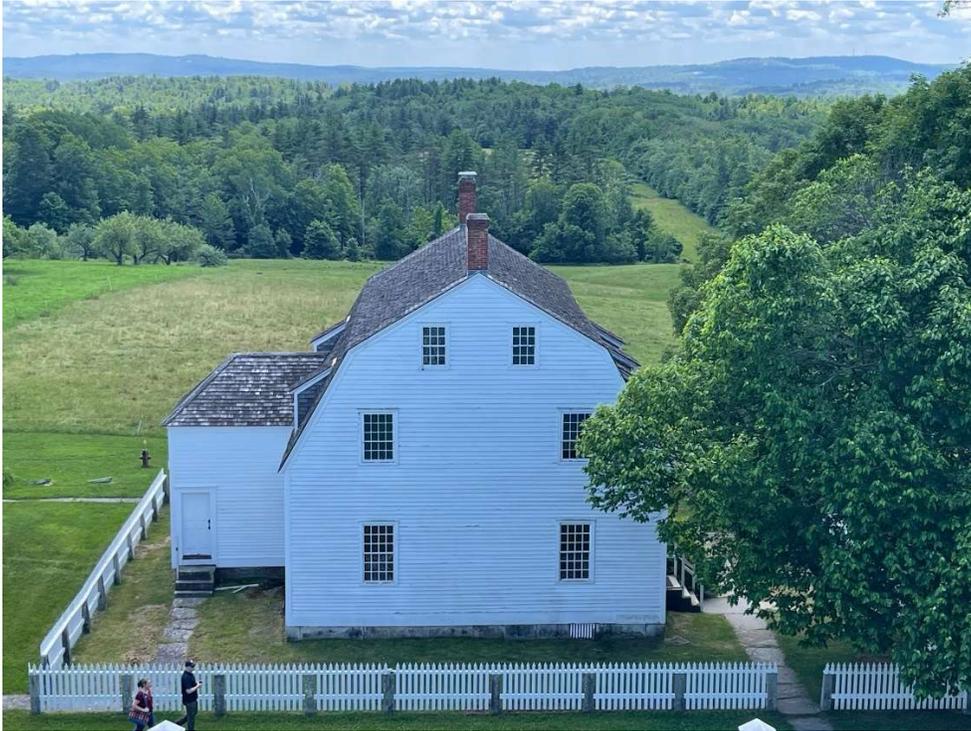
View of the Meeting House from the north, showing current condition.
E. Hammerstedt, June 27, 2025

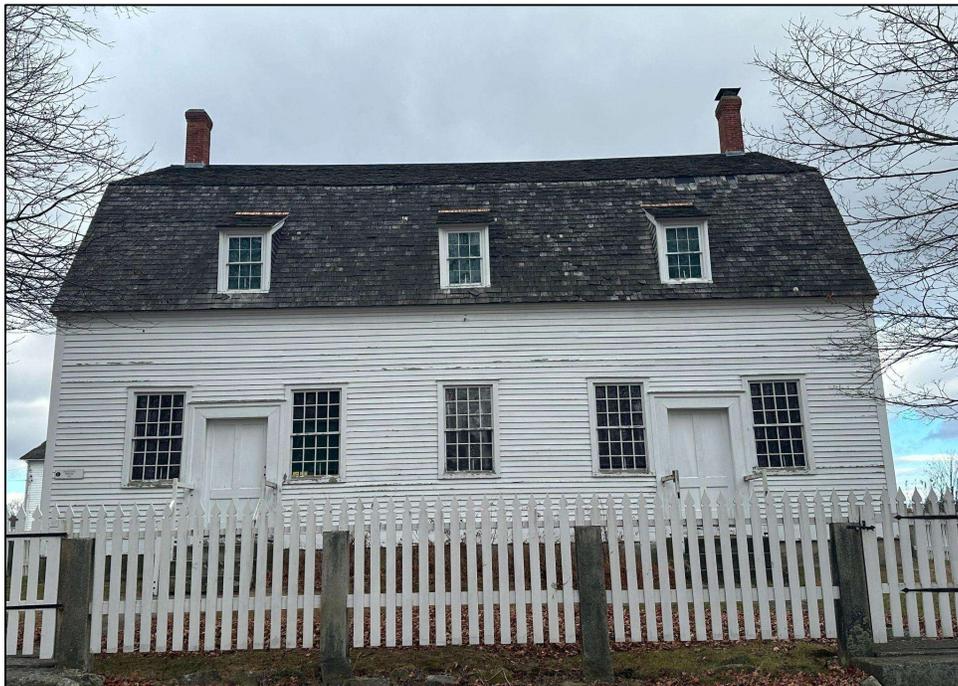
Exterior Trim, Siding, Fenestrations and Railings – Existing Condition: The exterior of the building on the whole is performing well; with the signs of age and weathering one would expect of a building this old. Minor damage has been identified, particularly around window and door trim and sills.

Roof – Existing Conditions: The wooden shingle roof is showing signs of age and weathering. Many shingles are cupping or falling out. In some areas light can be seen coming through the roof into the attic space. Signs of water penetration seen in broken and discolored plaster indicate the roof is in need of replacement in kind.

Facade of the Meeting House facing east showing general condition of roof, siding, windows.
Mae Williams, Winter 2024.

Exterior Trim, Siding, Fenestrations and Railings – Recommended Repairs: There are a number of minor repairs to be performed on the windows, doors and trim around the exterior of the building. In addition to the individual repairs, the entire exterior should be properly scraped, primed and re-painted. The whole of the building should be encompassed with scaffolding both to provide access to all exterior areas and to properly contain lead paint during the scraping process. This will also provide the access needed to complete repairs of any damaged windows.

Roof – Recommended Repair: Originally the roof would have been covered with a thick 5/8" white cedar shake. The existing shingles are 3/8" thick and failing. A new in-kind replacement for this roof covering can be provided locally and created with the thicker and longer shake. A 5-inch reveal on a 5/8" by 18" shake provides triple coverage with the overlap.

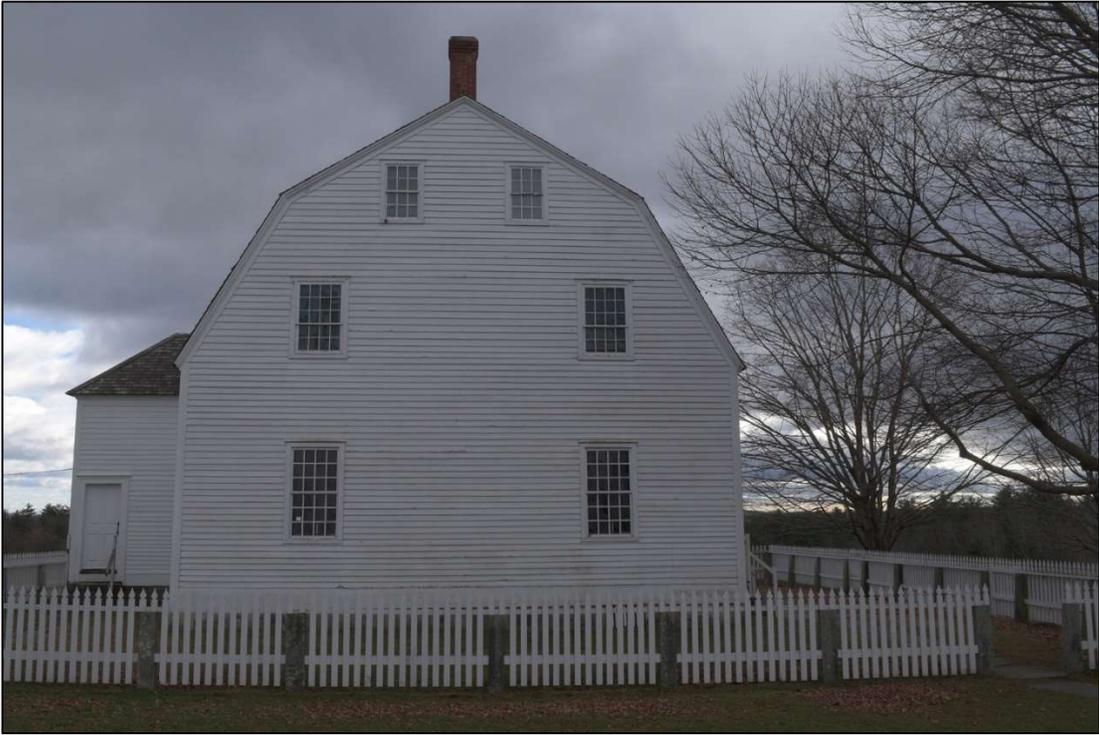
North elevation of the Meeting House. Mae Williams, Winter 2024.

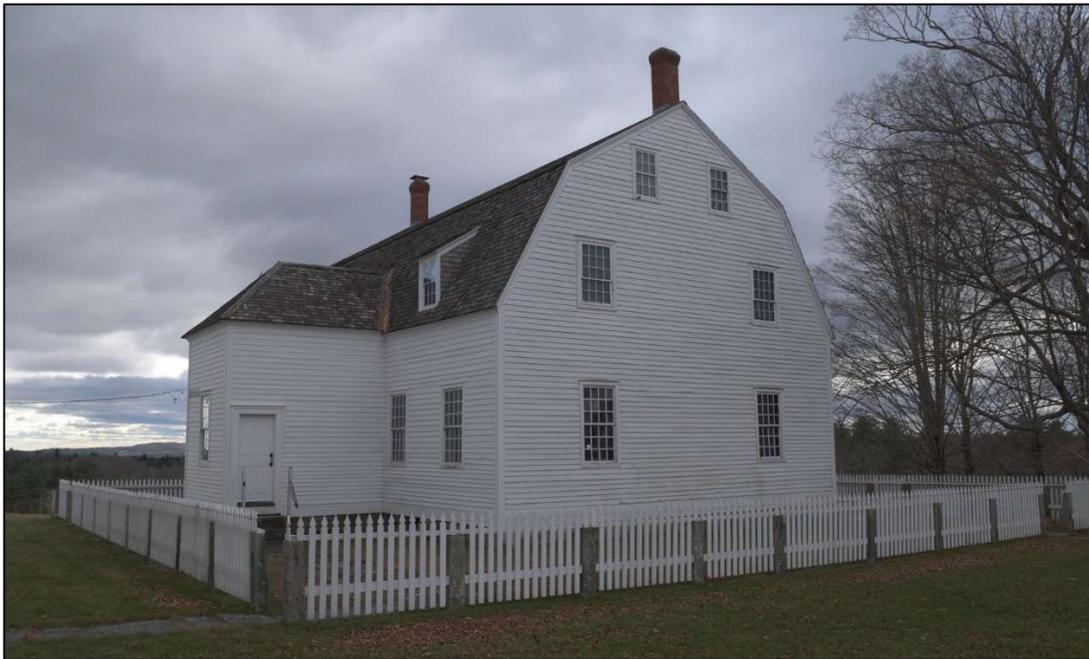
Church Family Meeting House, facing southwest. Mae Williams, Winter 2024.

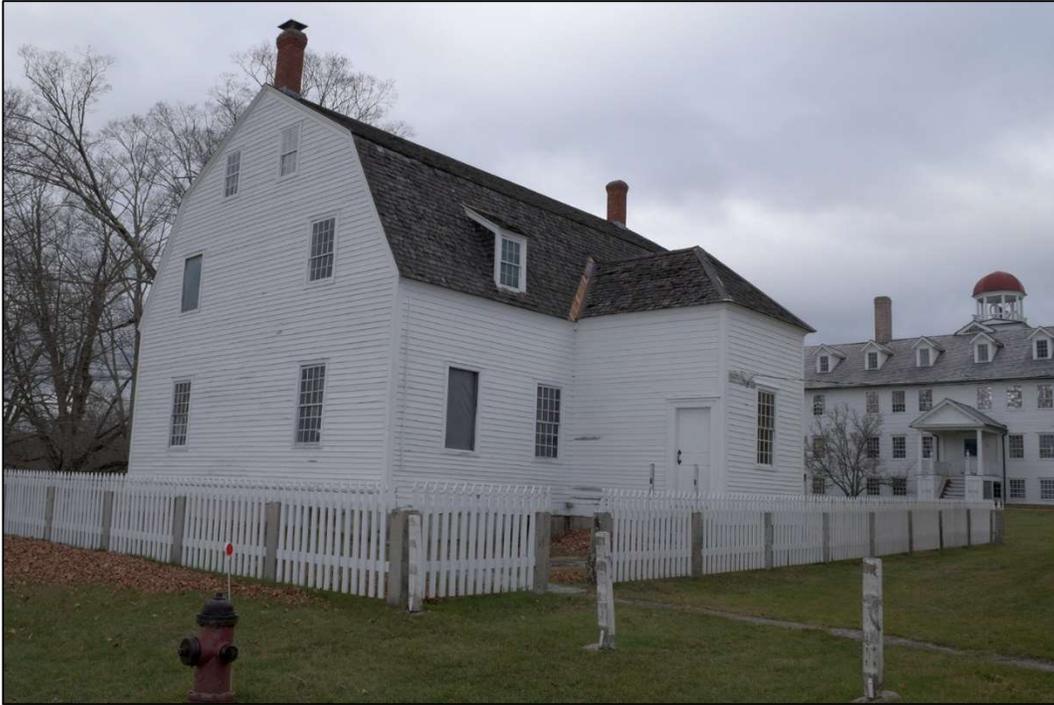
Church Family Meeting House, facing northwest. Two windows had been removed for study to help determine the specific scope of preservation work. Mae Williams, Winter 2024.

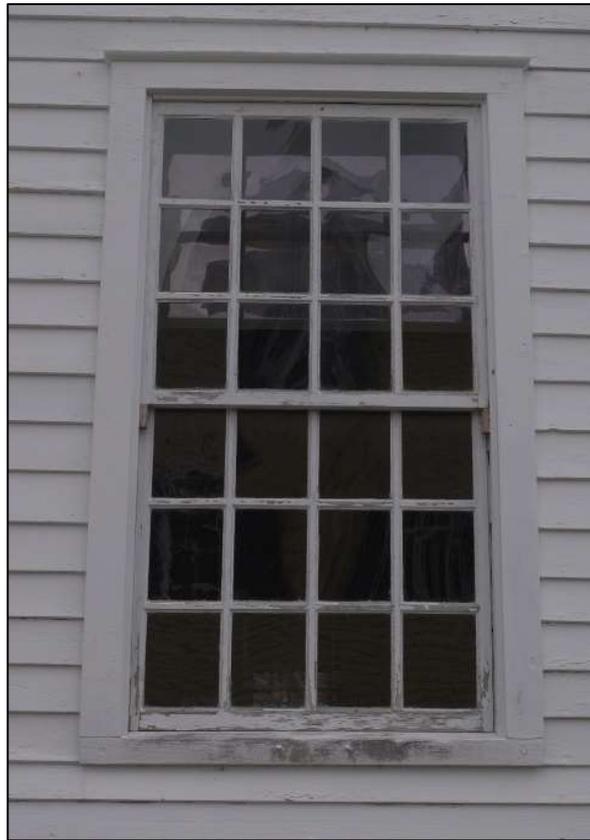
First floor meeting room window, representative example. Mae Williams, Winter 2024

Windows – The existing historic window sash are being preserved, per an HDC application with prior approval, outside the scope of this review.

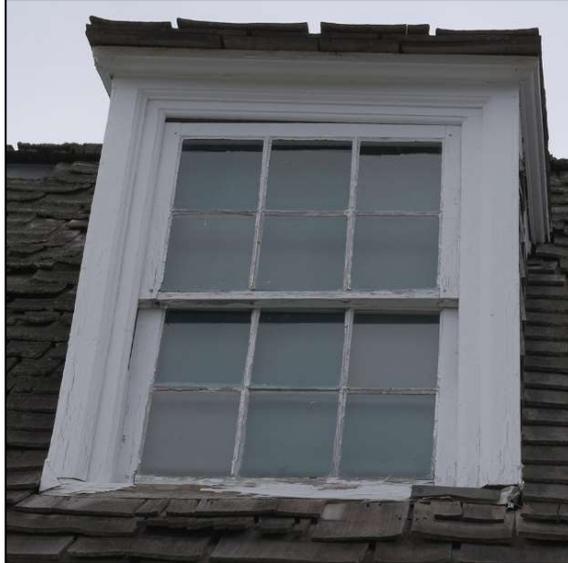
Dormer window, representative example. Also shows condition of existing cedar shingle roof.
Mae Williams, Winter 2024

Erecting scaffolding for the exterior restorations provides the opportunity to safely complete work on the meeting house roof. The best way to address the roof that will match the longevity of the repairs to the exterior walls would be to completely remove and replace the wooden shingles.

Stripping the roof would allow the integrity of all of the sheathing boards to be assessed before covering with a weather resistant sheeting. In addition, regular courses of pine strapping should be added to lift the shingles away from the roof surface, providing a layer of air to allow shingles to properly dry after weather events. New white cedar shakes should be installed over this layer of strapping with proper lead/copper flashings where appropriate.

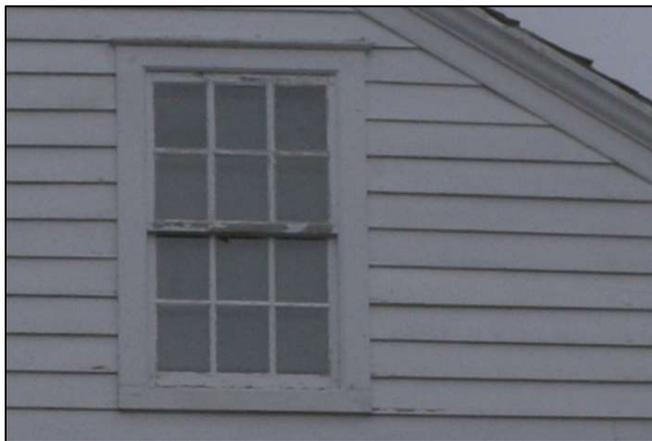
Third floor/attic window, representative example. Mae Williams, Winter 2024

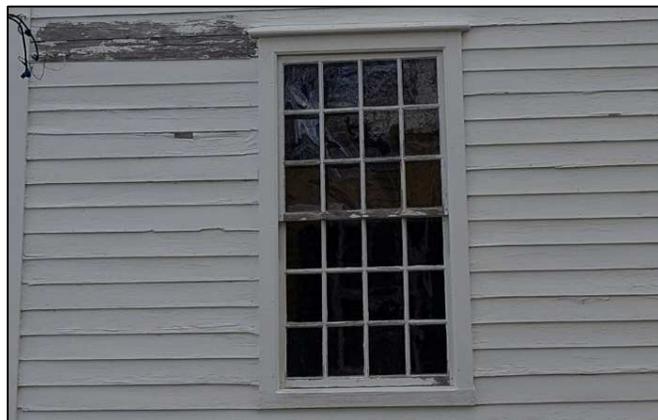
Window in 1815 east addition, representative example. Also showing condition of siding and trim. Mae Williams, Winter 2024

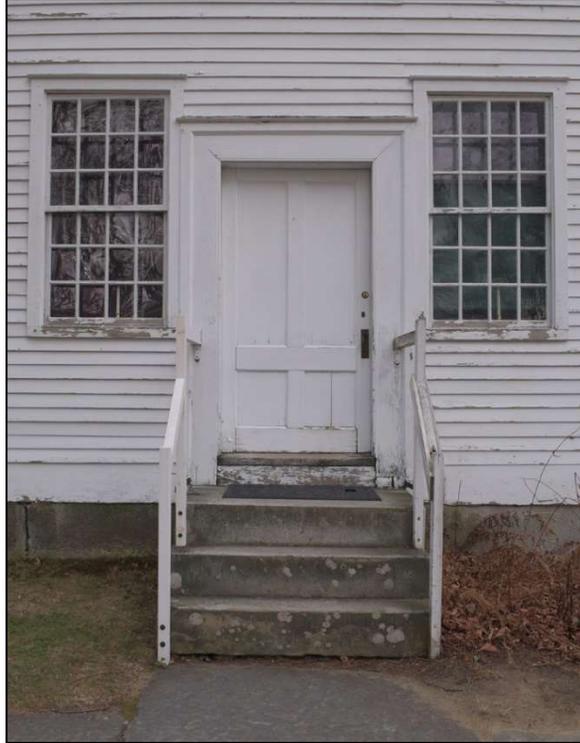
North entrance, which is like the south entrance but south handrails are in worse condition with elements missing. Also showing condition of siding, trim, threshold, etc. Mae Williams, Winter 2024

Each set of the exterior entry railings should be repaired or replaced in kind. These should be built using mortise and tenon joinery and securely fastened to the existing stone steps.

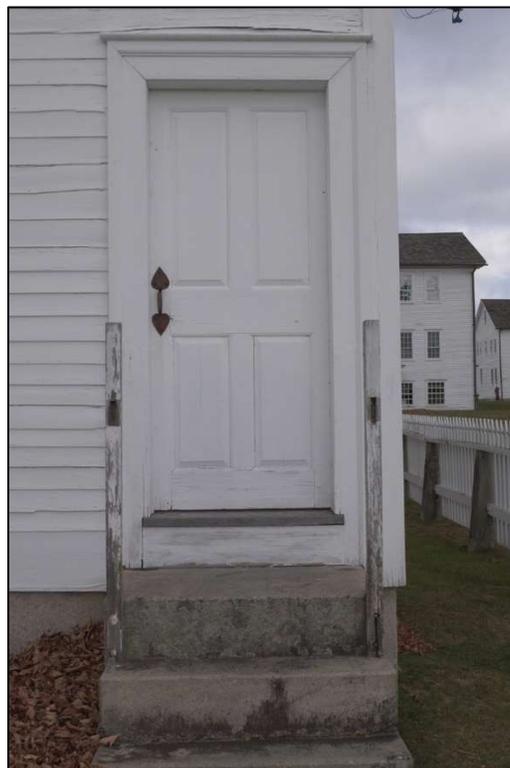
South entrance on 1815 addition, which is like the north entrance. Mae Williams, Winter 2024
